**Region 9 Enforcement Division**  
**75 Hawthorne Street**  
**San Francisco, CA 94105**

<b>Inspection Date(s):</b>	9/28/2015		
<b>Time:</b>	<b>Entry:</b> 1:20 pm	<b>Exit:</b> 3:20pm	
<b>Media:</b>	Water		
<b>Regulatory Program(s)</b>	Clean Water Act NPDES /CAFO Dairy		
<b>Company Name:</b>	El Dorado Dairy		
<b>Facility or Site Name:</b>			
<b>Facility/Site Physical Location:</b>	<b>Ex. 6 Personal Privacy (PP)</b>		
<b>Geographic Coordinates:</b>			
<b>Mailing address:</b>	PO Box 1590, Chino, CA, 91708-1590		
<b>Facility/Site Contact:</b>	Ed Haringa	<b>Title:</b> Operator	
	<b>Phone:</b> Ex. 6 Personal Privacy (PP)	<b>Email:</b>	
<b>Facility/Site Identifier:</b>	NPDES CAG018001 / Order R8-2013-0001, General waste discharge requirements for CAFOs (dairies and related facilities)		
<b>NAICS:</b>	112120 Dairy Cattle and Milk Production		
<b>SIC:</b>	0241 Dairy Farms		
<b>Facility/Site Personnel Participating in Inspection:</b>			
	<b>Name</b>	<b>Affiliation</b>	<b>Title</b>
	Ed Haringa		Operator

**SANTA ANA REGIONAL WATER QUALITY CONTROL BOARD  
INSPECTION REPORT**

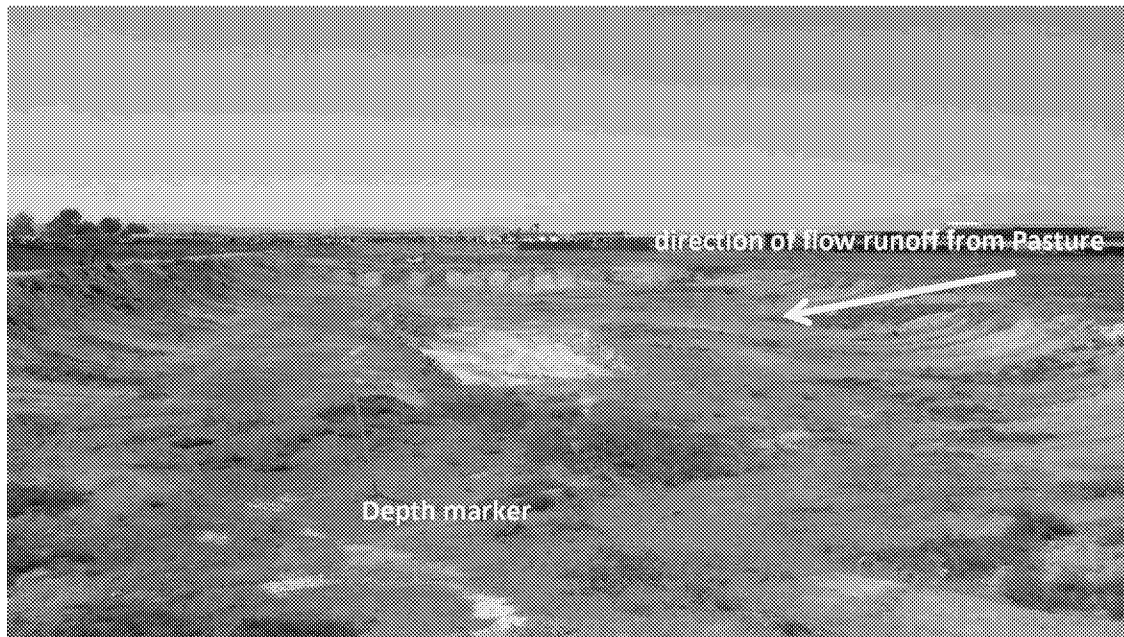
Photo 1: Southeast corner of facility. Southeast Pond and pasture areas. View looking west.

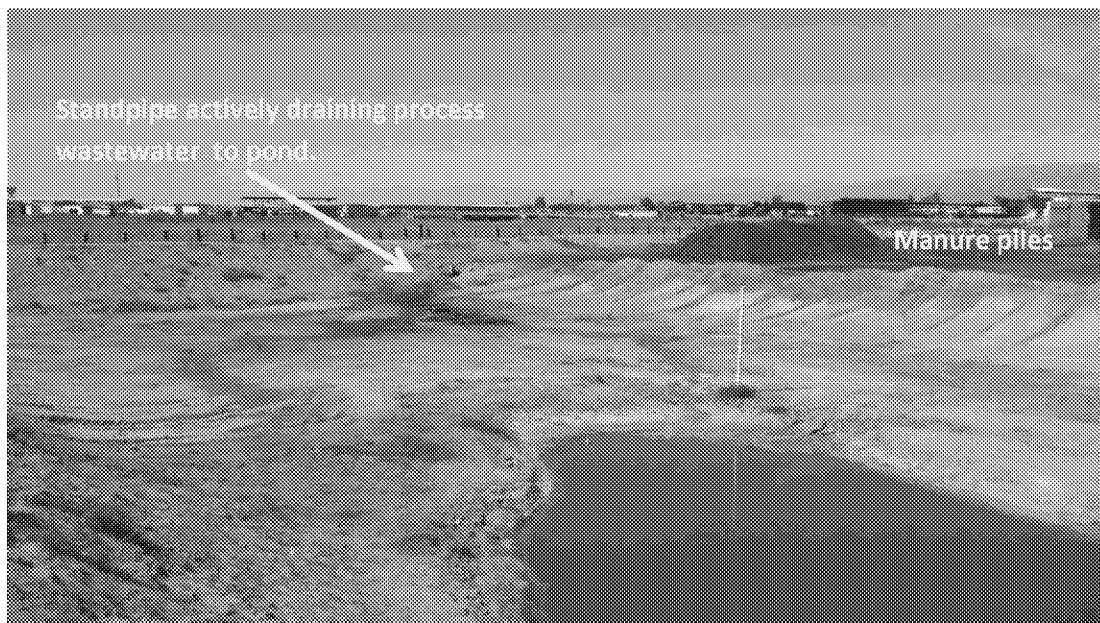
At the time of the inspection, the southwest pond held several feet of wastewater. (photo 2) The operator noted the water remained from the rains in July. The operator stated most wastewater is either evaporated or pumped to pasture with little infiltration. The ponds are not maintained to encourage infiltration. At the time of the inspection, wastewater was actively draining to the standpipe in the southwest pond. The water originated from misting at the western edge of the corrals. Standing water was observed at the western edge of the corrals due to misting.

Photo 2: Southwest corner of facility.

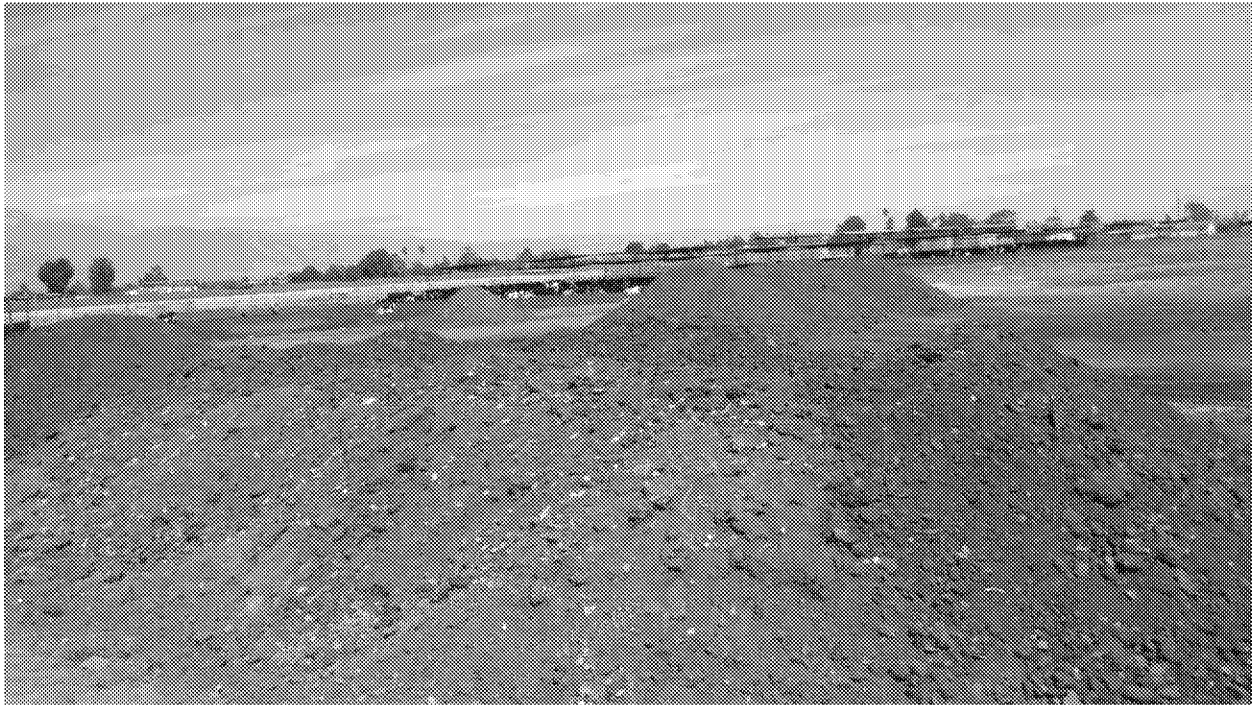
Drainage from the northern corrals and hay barn drains westward in a ditch along the northern boundary westward to a drain located in the northwest corner of the facility. (see photo 3). The drain is piped to a standpipe discharging to the southwest pond (see photo 2).

Photo 3: Manure storage areas, looking northeast across facility.

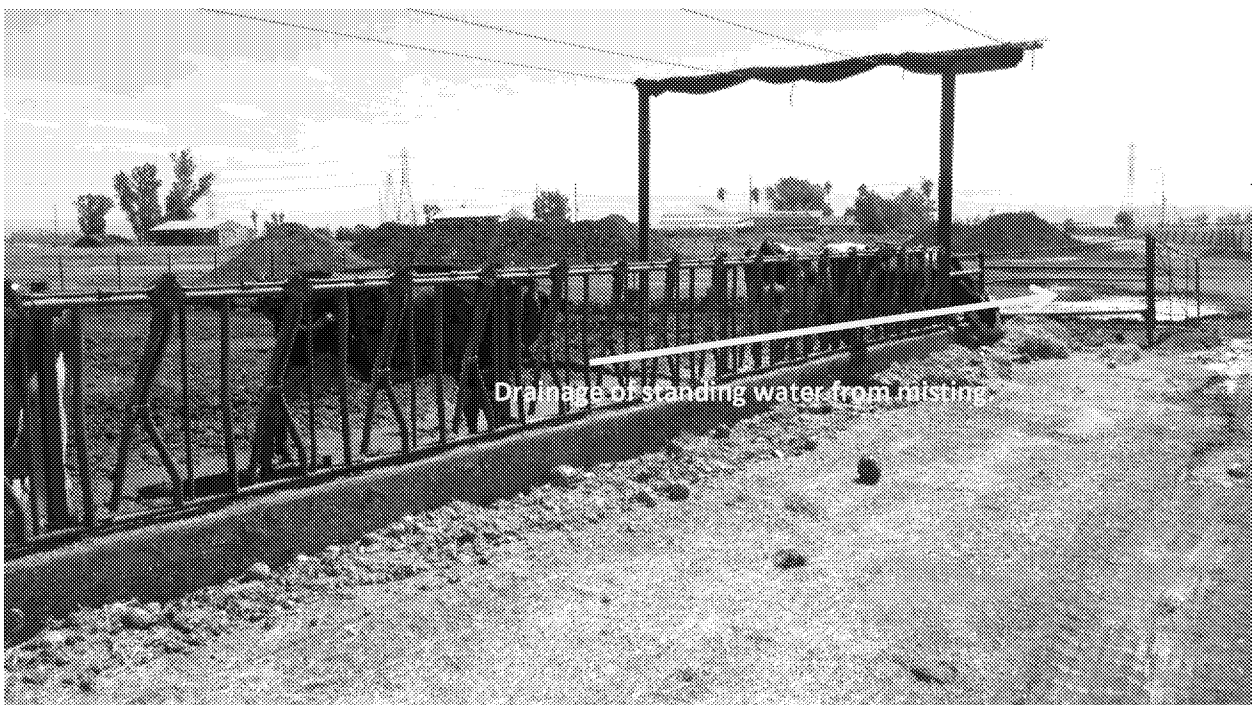
Photo 4: Western edge of corrals. Misting water draining to SE pond.

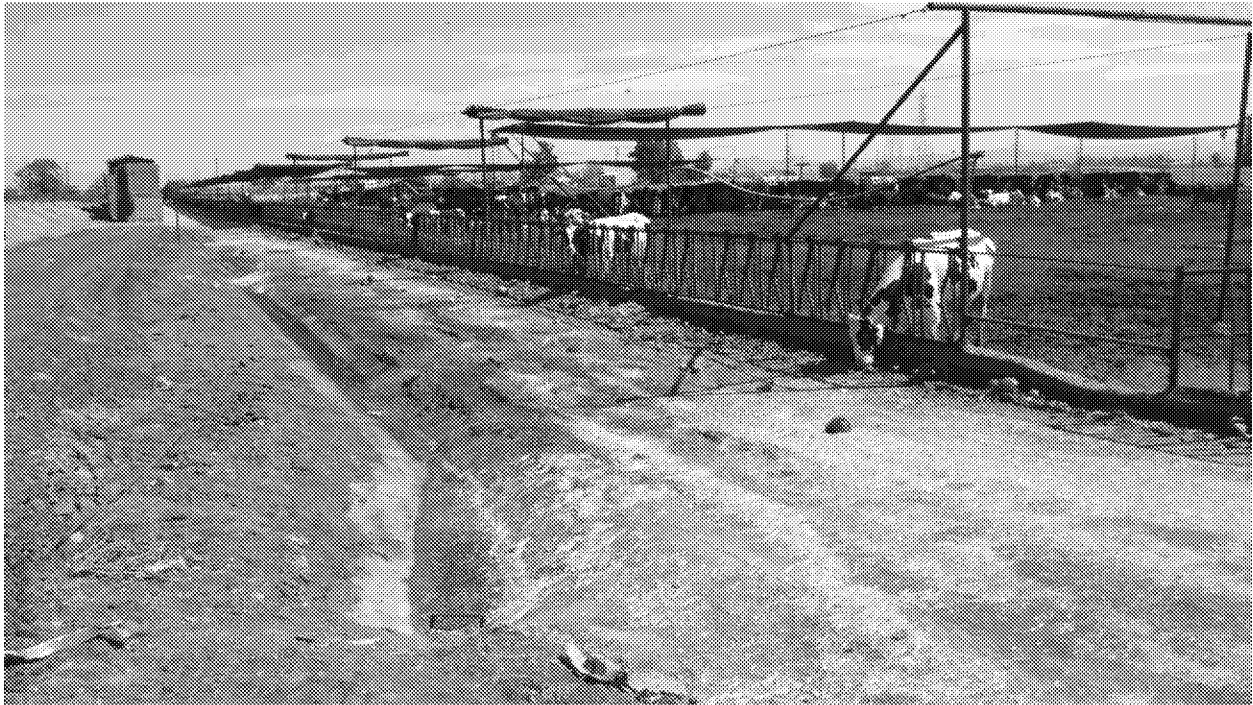
Photo 5: Drainage along northern boundary.

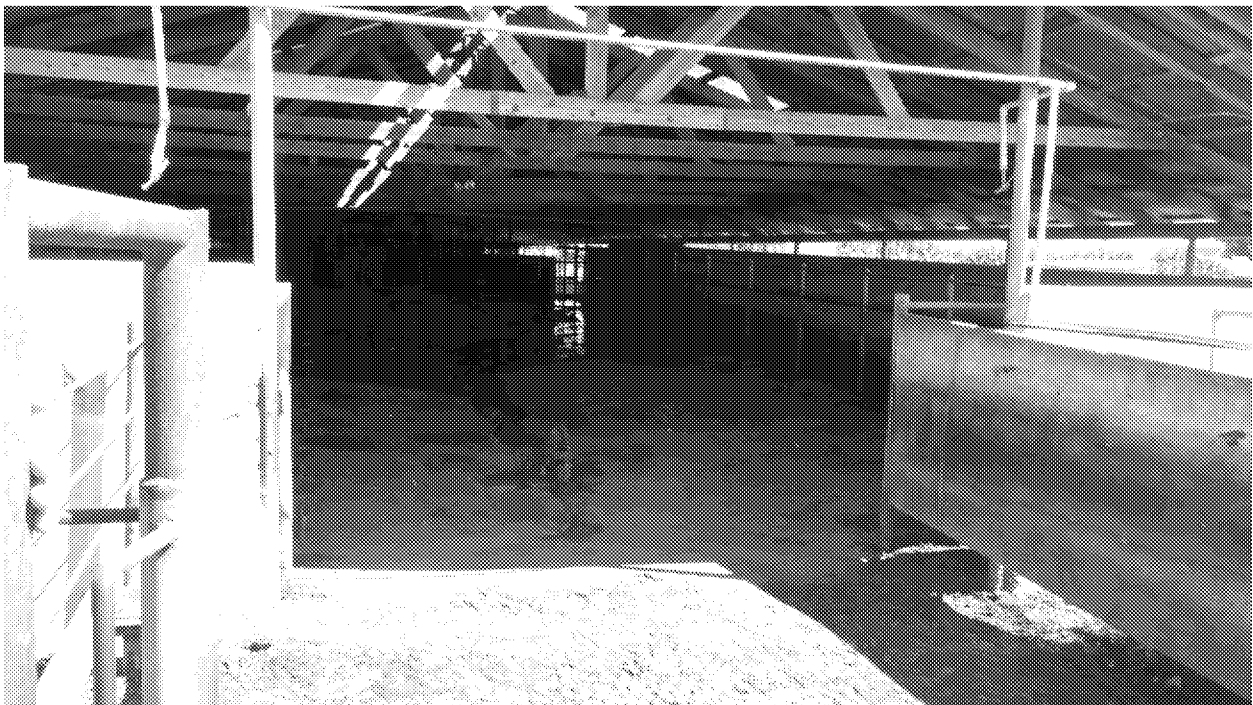
Process water from the milk barn drains to a pipe which is directed to pasture areas in the center of the dairy (photo 6). There are several check valves in the pasture areas where the operator directs wastewater to different areas of the pasture. Pasture is planted with ryegrass. Stormwater that overflows the pasture areas, along with stormwater from the corrals, sheet flows directly into the southeast pond (photo 1). At the time of the inspection, the southeast pond was dry. At the time of the inspection, a section of the southeast pond had been scraped below grade. The operator explained this was to facilitate a ponding area to collect pond water so that it could be pumped back to the pasture areas for irrigation.

Photo 6: Washwater from empty milk barn area going to drain. Drain is directed to pasture area.
